Omada, FOREST PRODUCTS LABORATORIES

CONCENTRATIONS OF WATER-SOLUBLE PRESERVATIVES IN TREATED TIMBER

G.E. Moore

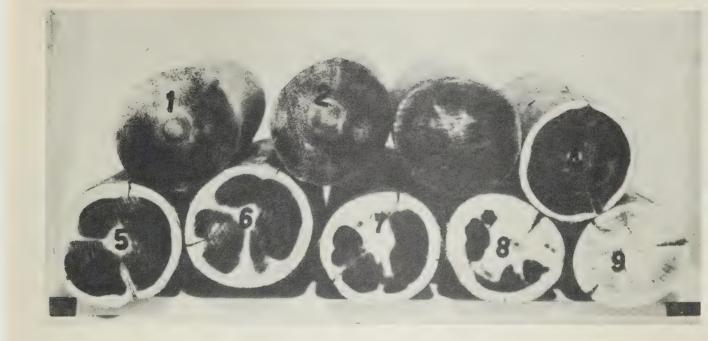
Plate 1. -- Cross-sections of Post No. 372

Visual examination of the posts treated with zinc chloride was made by sectioning them at 10-inch intervals and spraying the freshly cut surfaces with potassium ferricyanide-potassium iodide-starch indicator solution, to show qualitatively the distribution and penetration of zinc chloride. A dark stain indicates the presence of zinc. Plates 1,2 and 3 are reproductions of photographs of the sections of each post. Sections number 1, 2, 3, 4, etc., were at points 20 inches below the ground-line, 10 inches below the ground-line at the ground-line 10 inches above the ground-line, and so on. It may be seen in Plates 1 and 2 that in sections above the ground-line, Nos. 4, 5, 6, 7 and 8, the preservative is not present at the circumference, while in Plate 3, showing Post No. 374, which was analysed in detail, it may be seen that in sections 4, 5, 6, 7, and 8, it is present near the circumference but not in the interior. In all posts heavier concentrations above the groundline than below were indicated.
